FINAL REPORT NUMBER 201U-MGA-04-06

SAFETY COMPLIANCE TESTING FOR FMVSS 201U
Occupant Protection In Interior Impact
Upper Interior Head Impact Protection

LAND ROVER IN THE UK
2004 LAND ROVER FREELANDER SE MPV
NHTSA No. C40602

MGA RESEARCH CORPORATION
446 Executive Drive
Troy, Michigan 48083

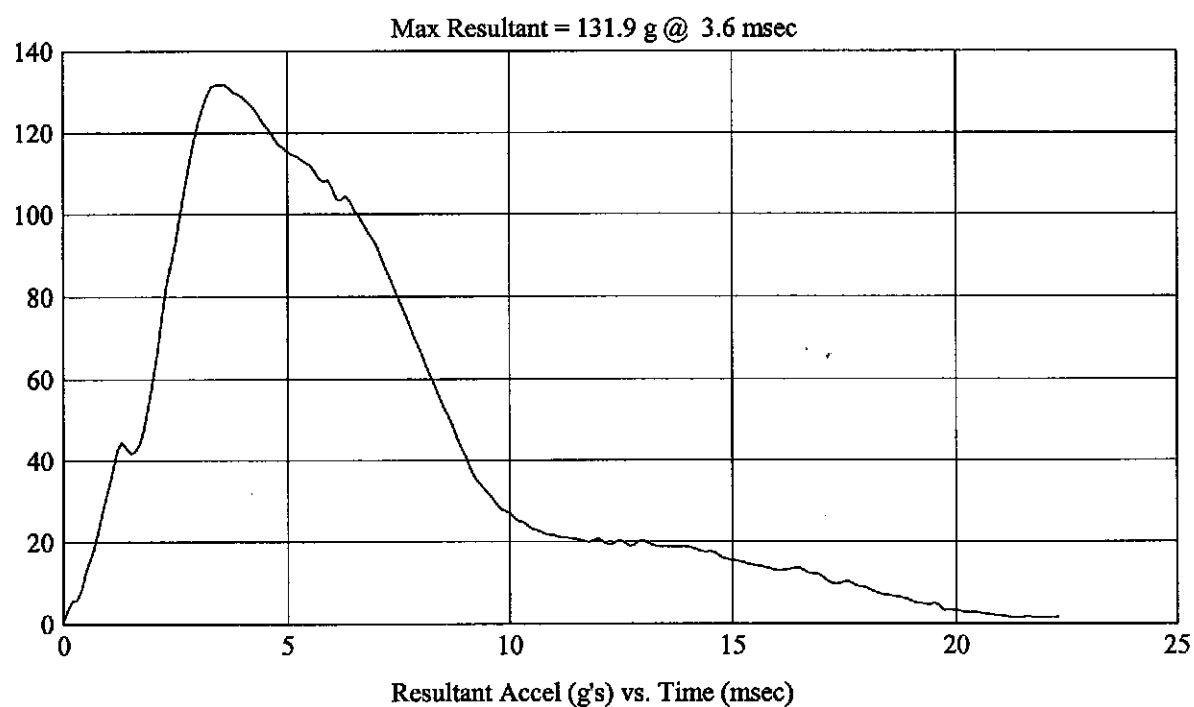
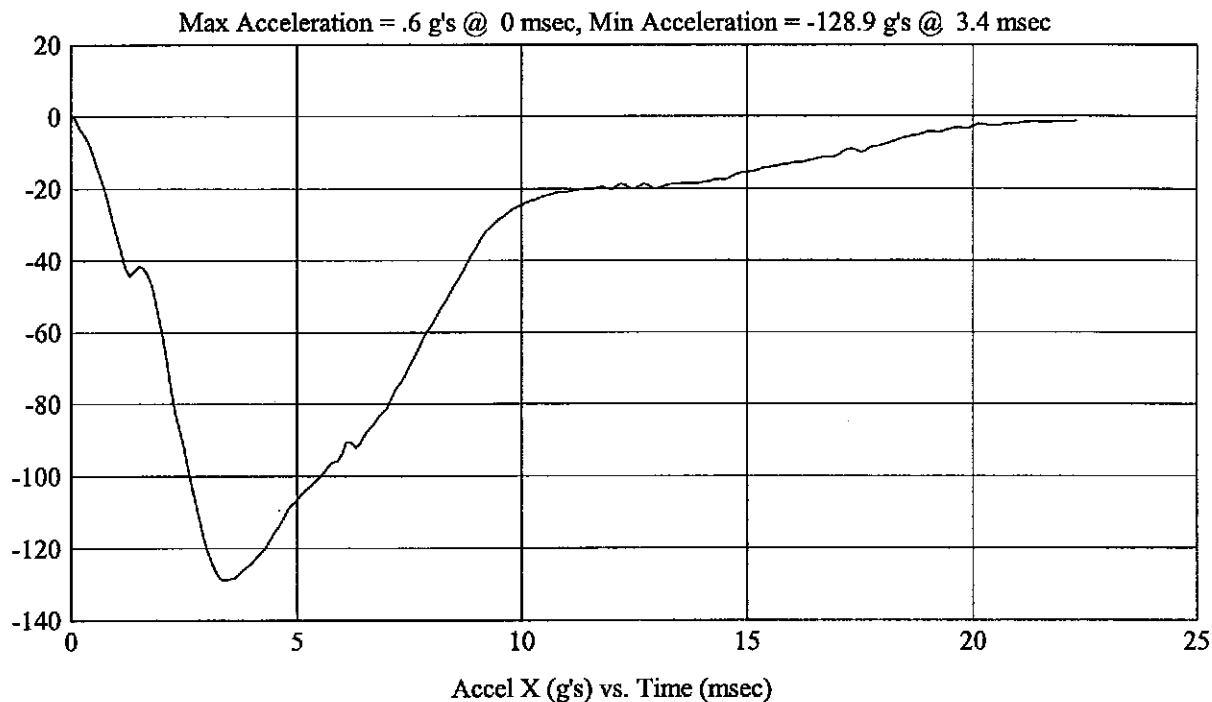
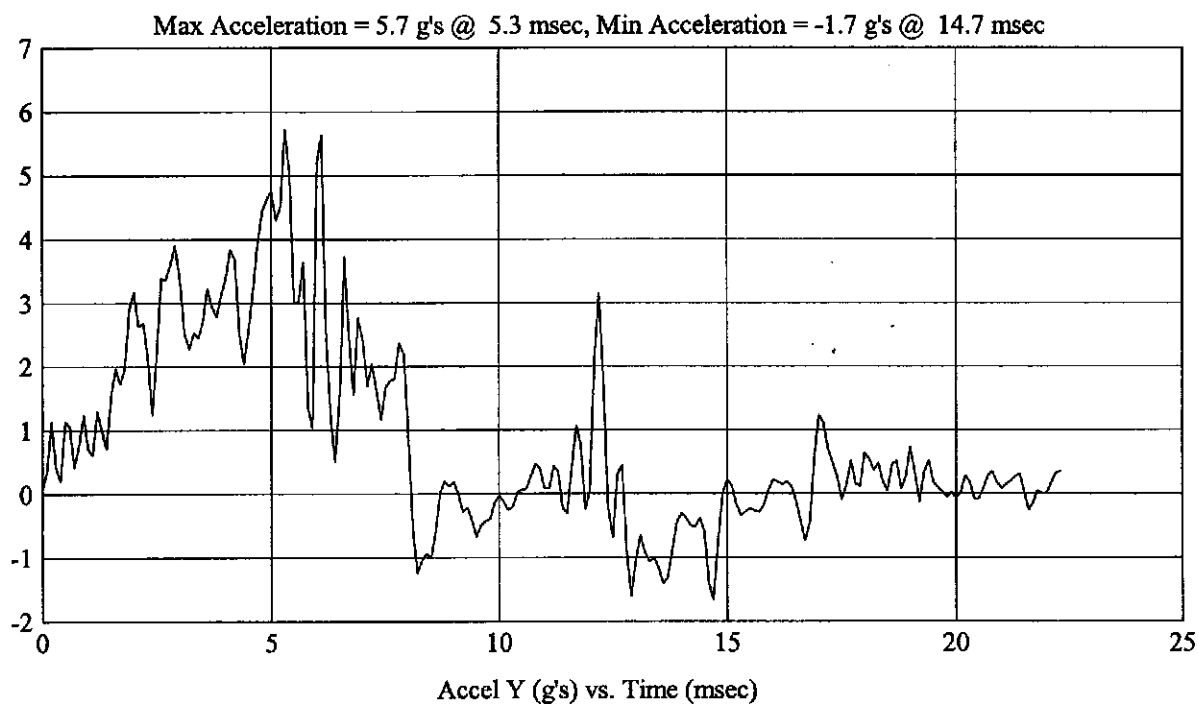
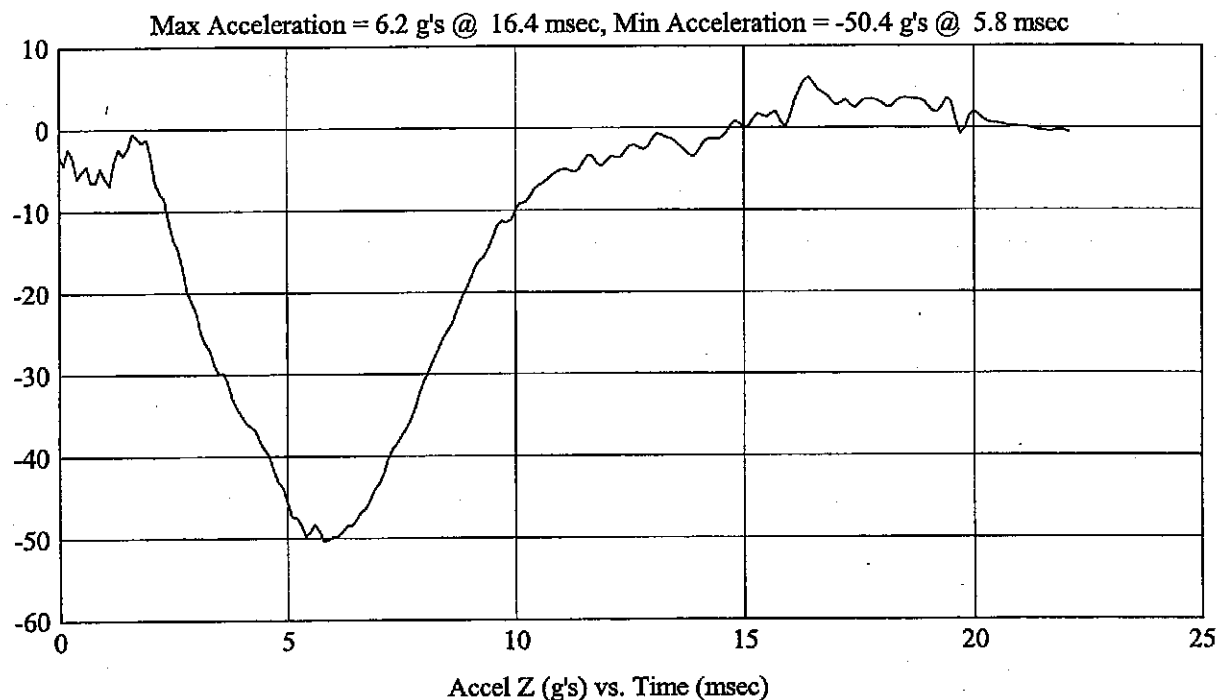
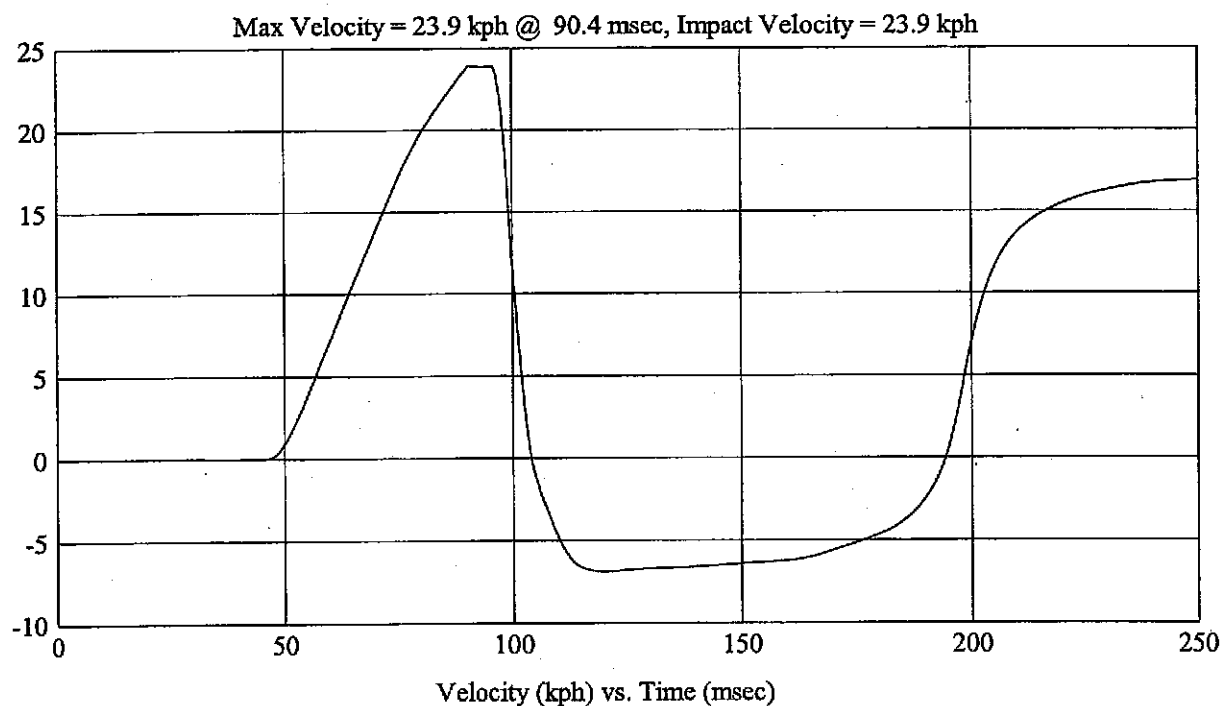
Model Year: 2004
Target: OP1
Vehicle Side: Right
Horz/Vert Angle: 90/0

HIC(d) = 689, HIC = 693, Delta T = 6 msec

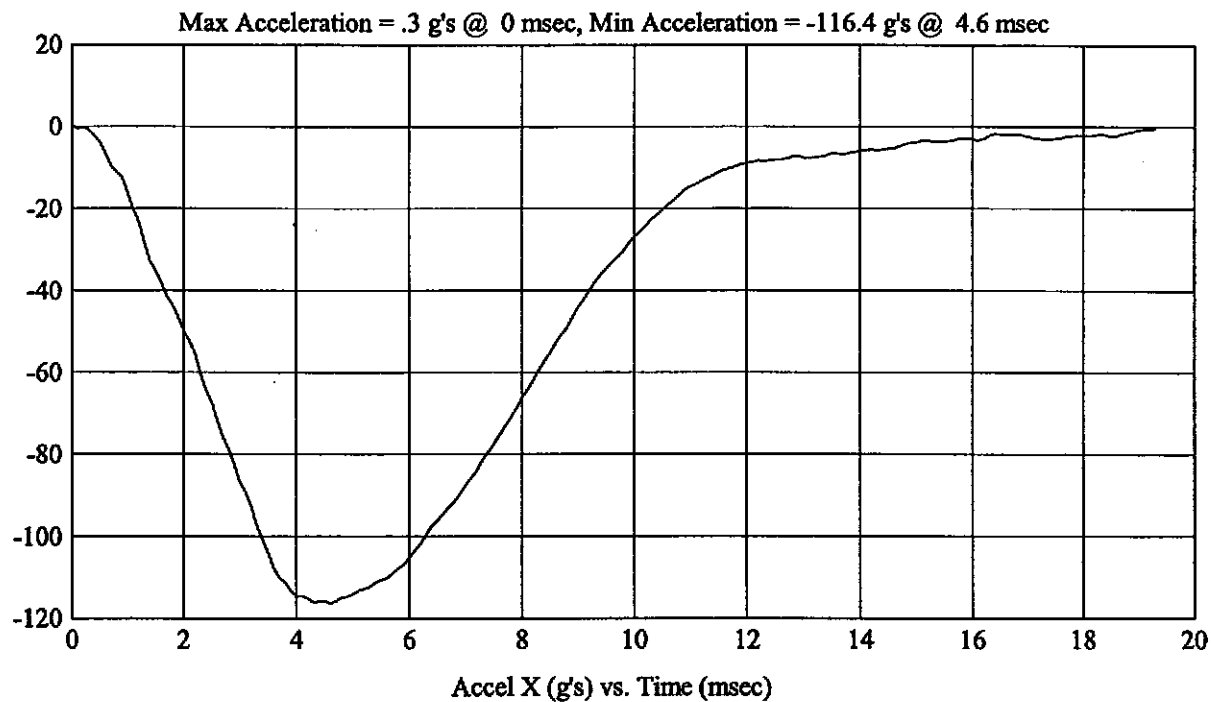
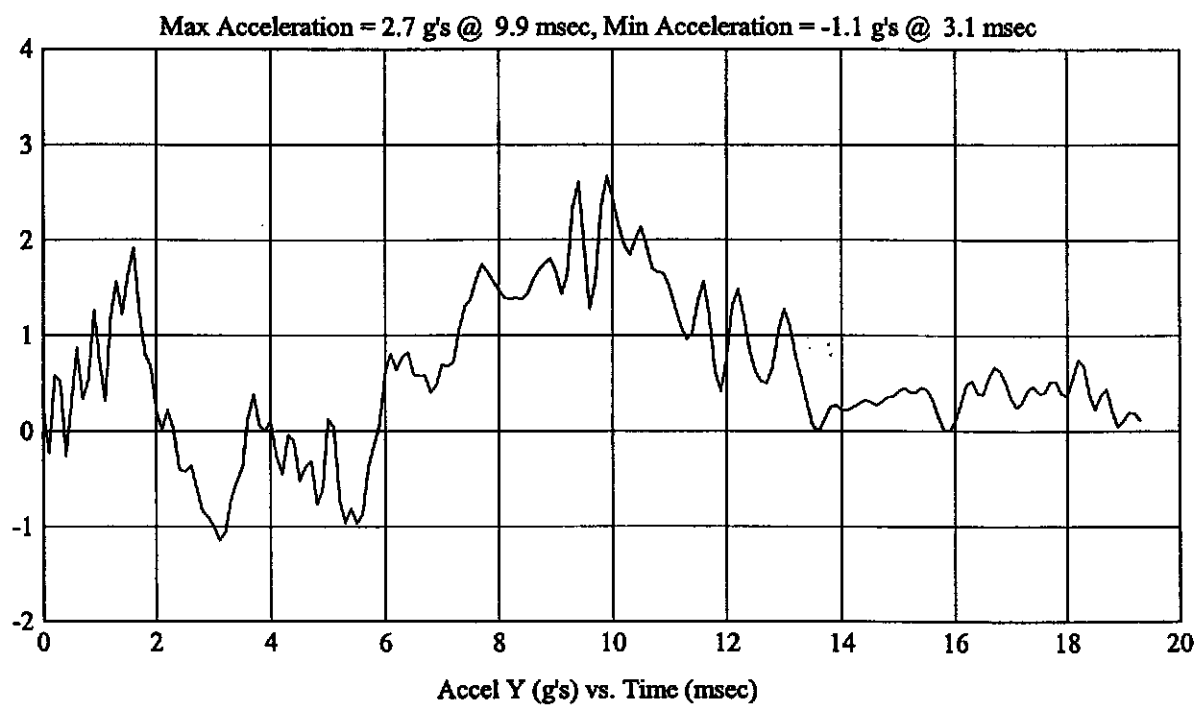
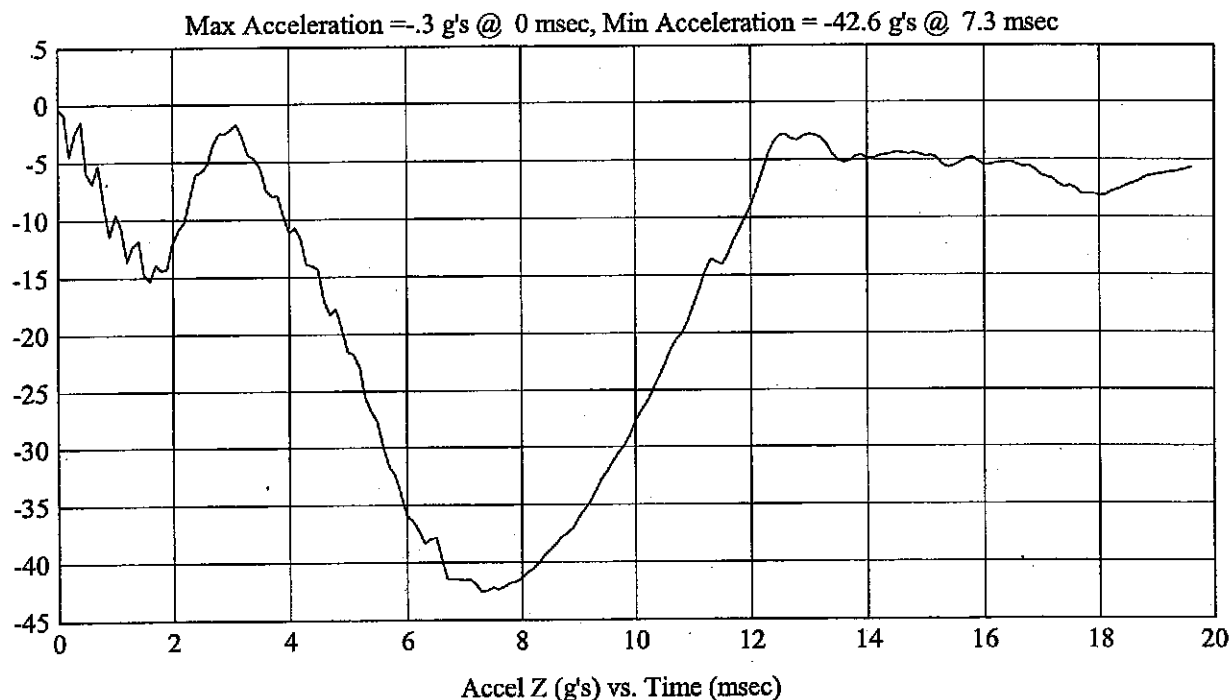
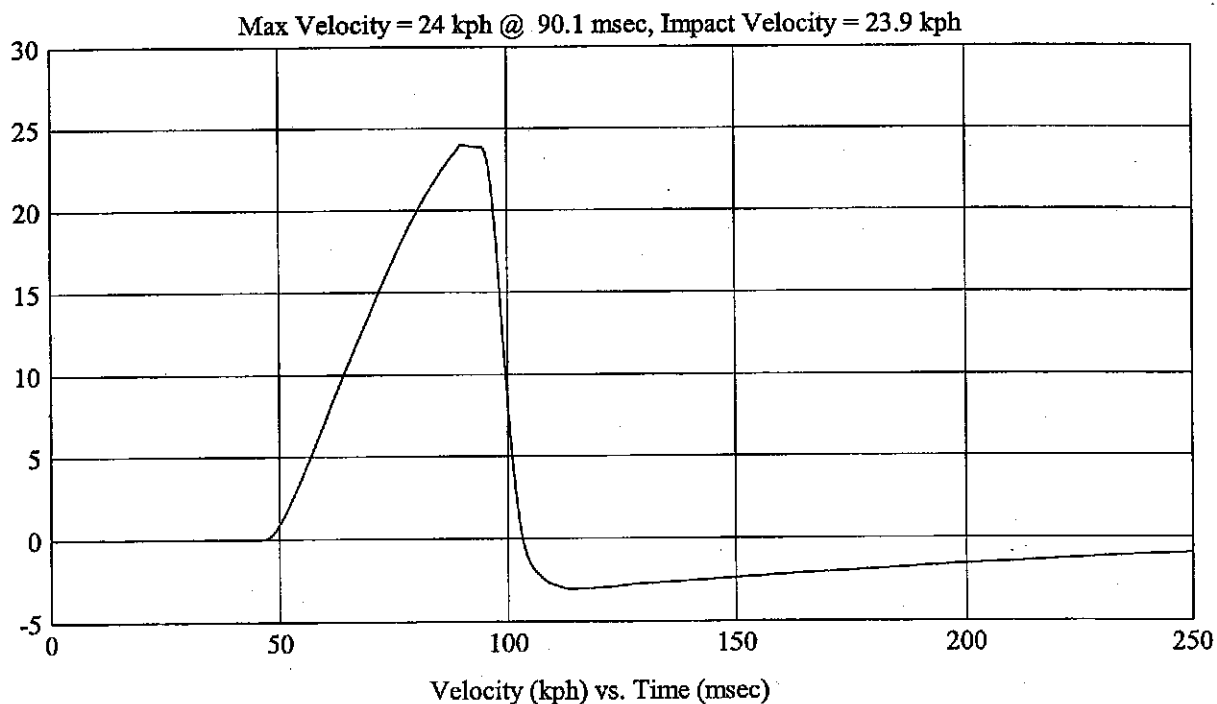
Model Year: 2004
Target: SR2(a)
Vehicle Side: Left
Horz/Vert Angle: 270/24

SR2(A) Left: Slight headliner deformation.

HIC(d) = 626, HIC = 609, Delta T = 6.8 msec

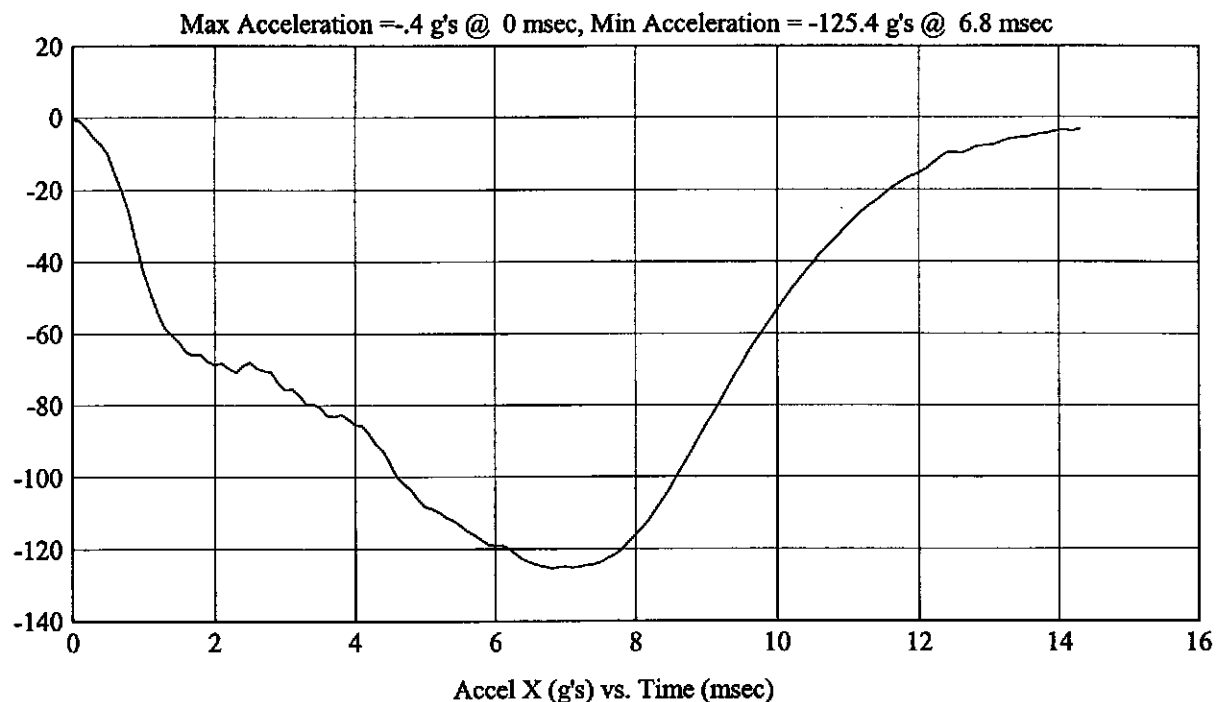
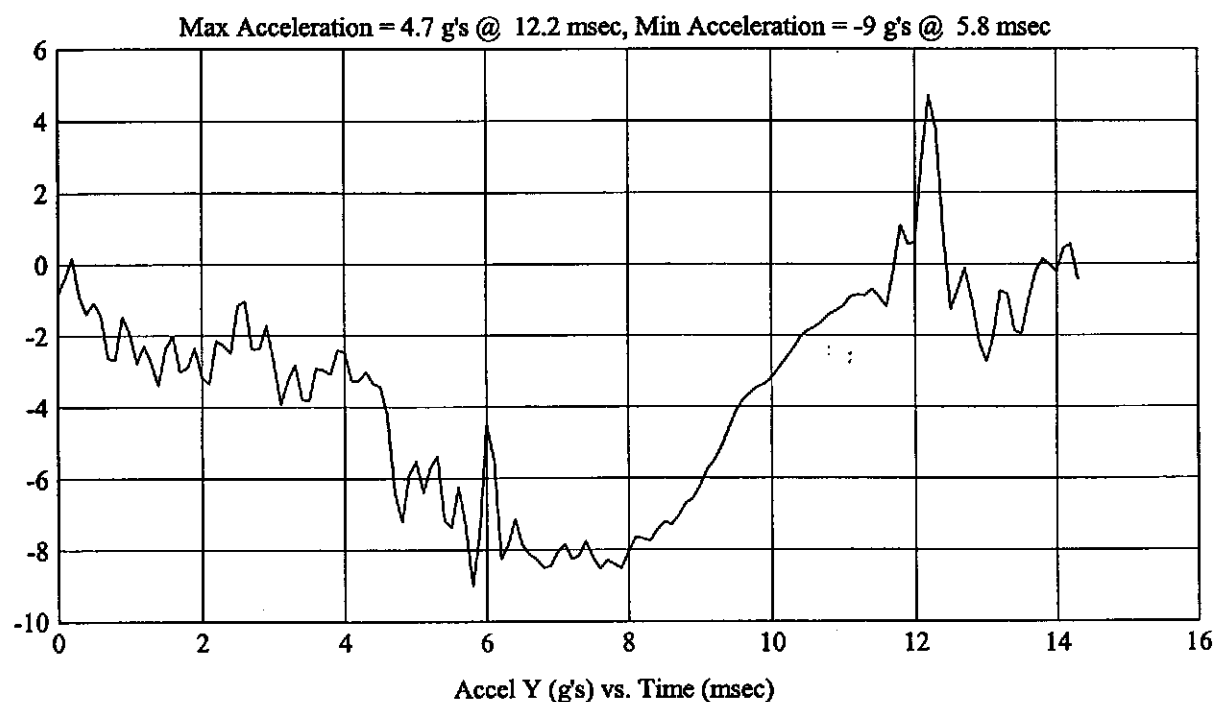
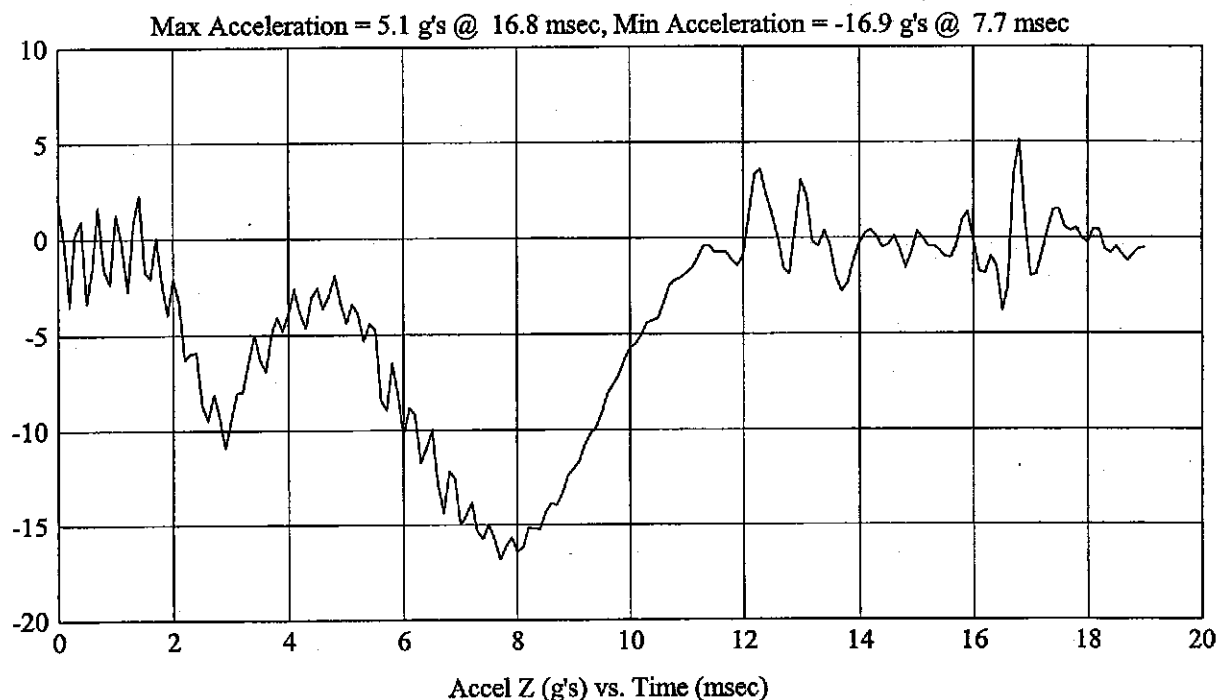
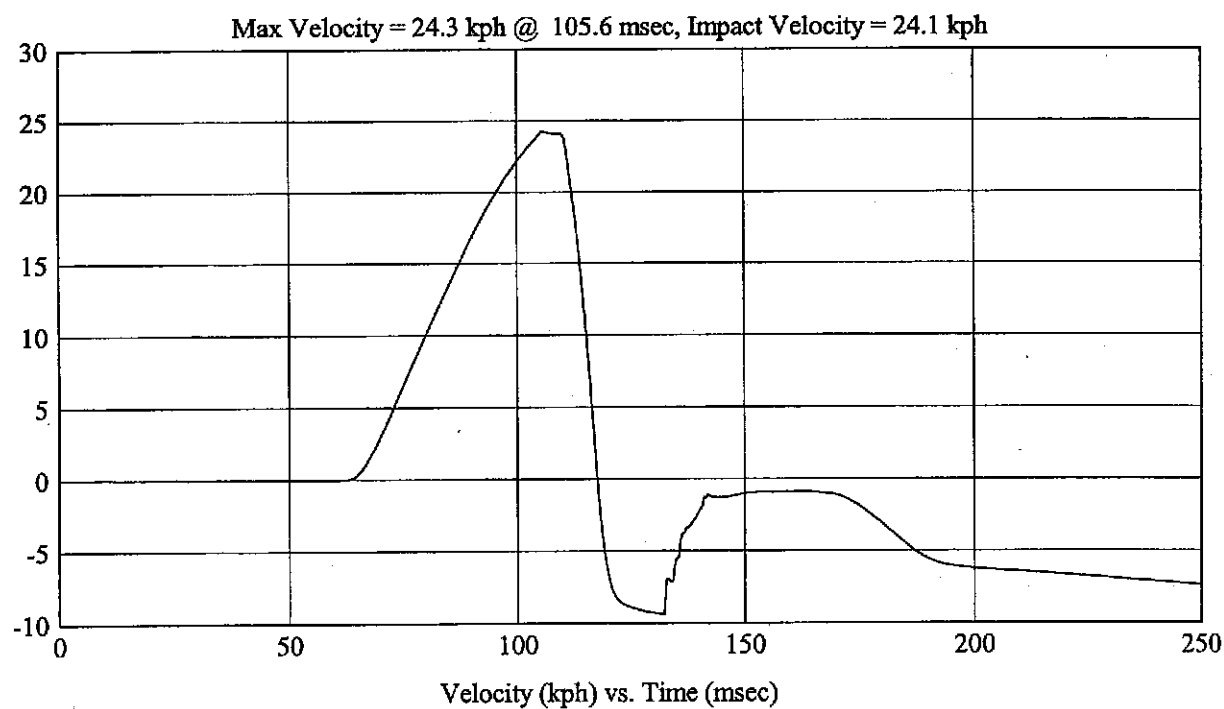
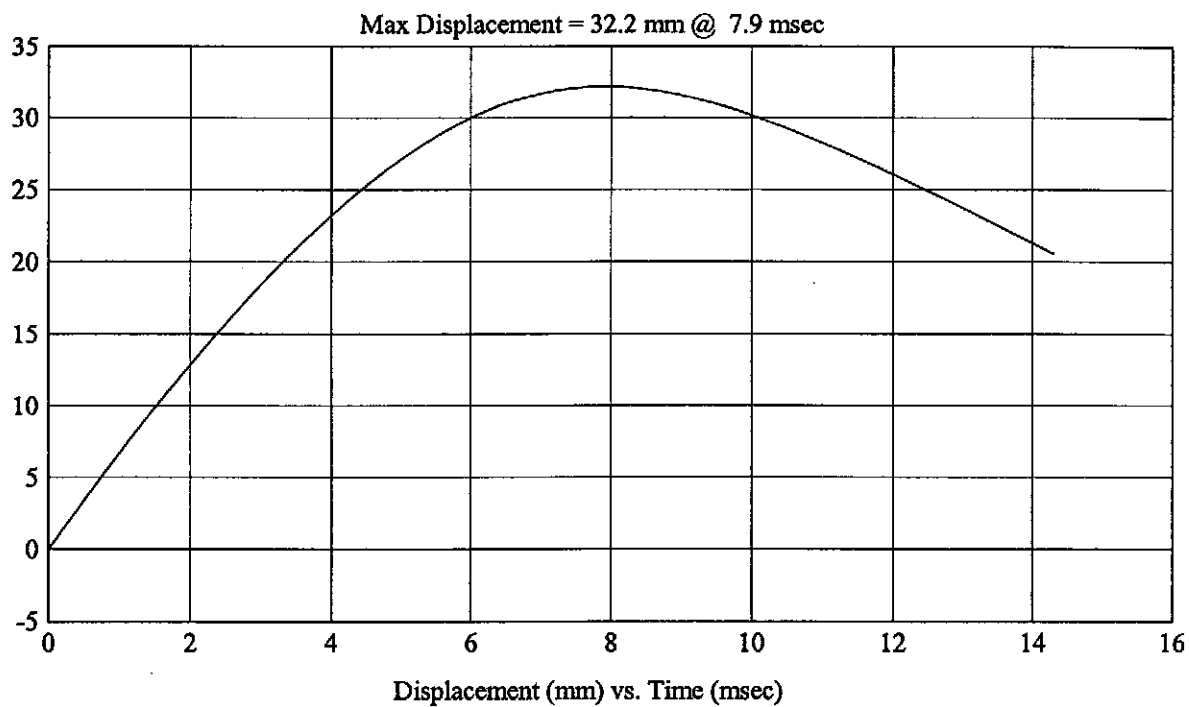
Model Year: 2004
Target: SR2(a)
Vehicle Side: Right
Horz/Vert Angle: 90/45

SR2(A) Right: The grab handle was compressed into the side rail.

HIC(d) = 746, HIC = 768, Delta T = 8.6 msec

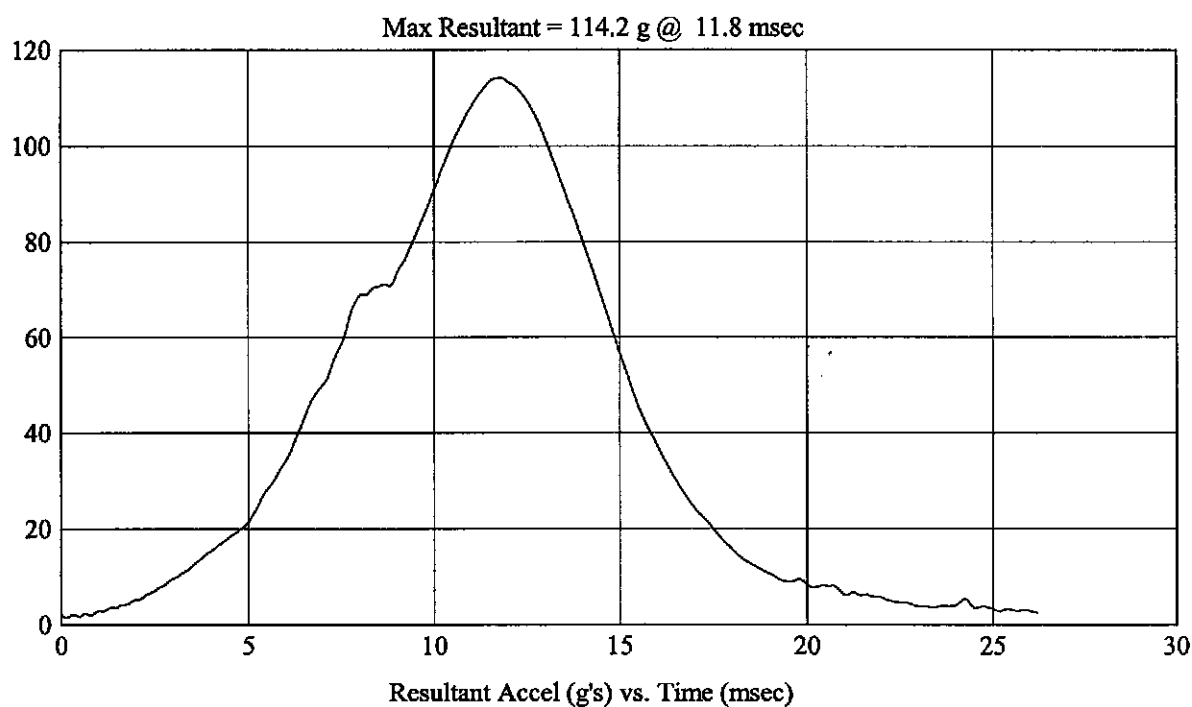
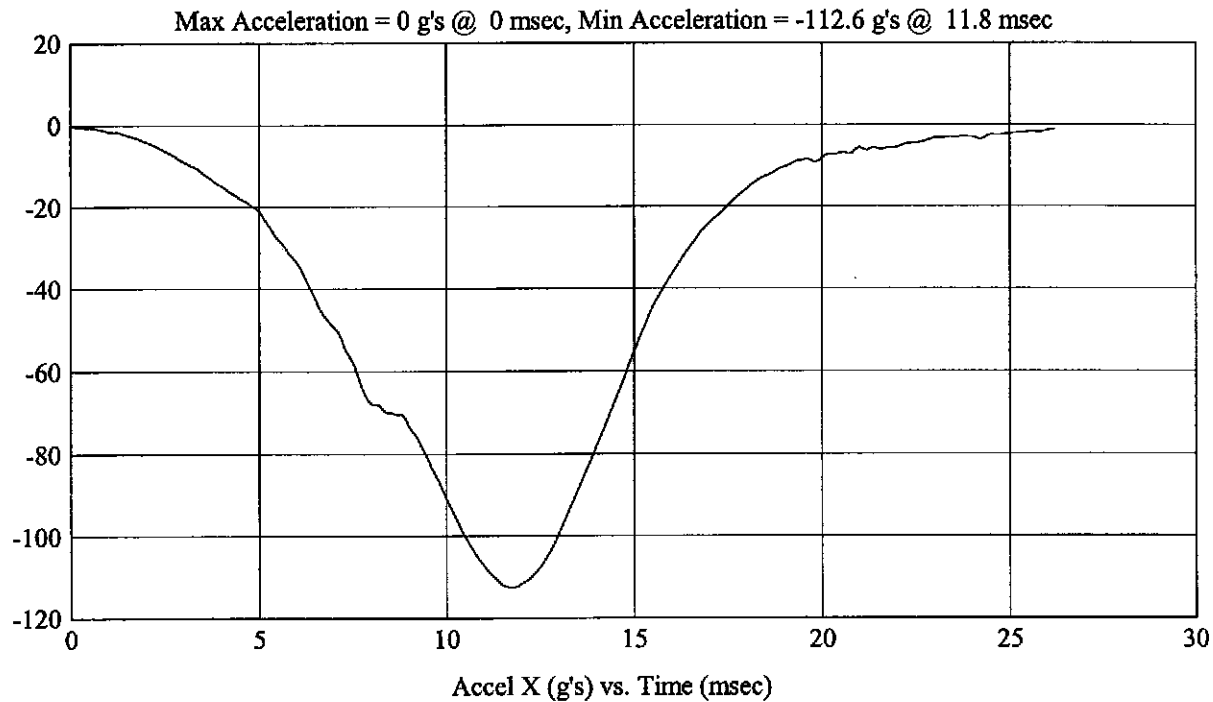
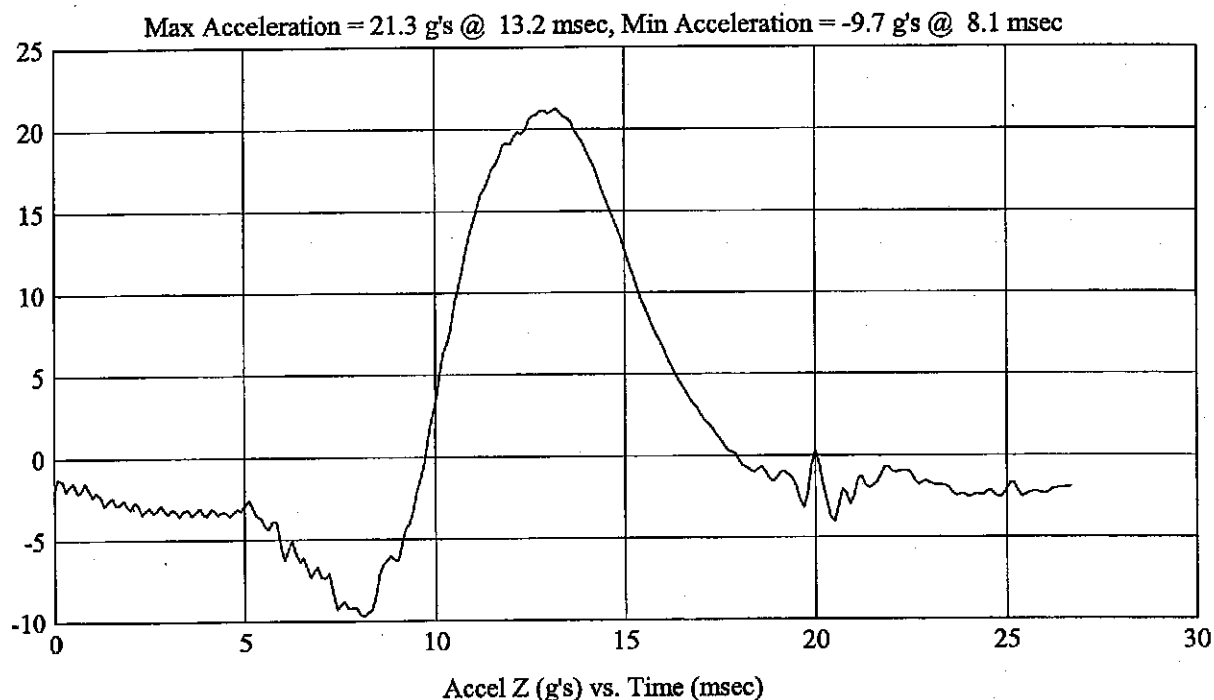
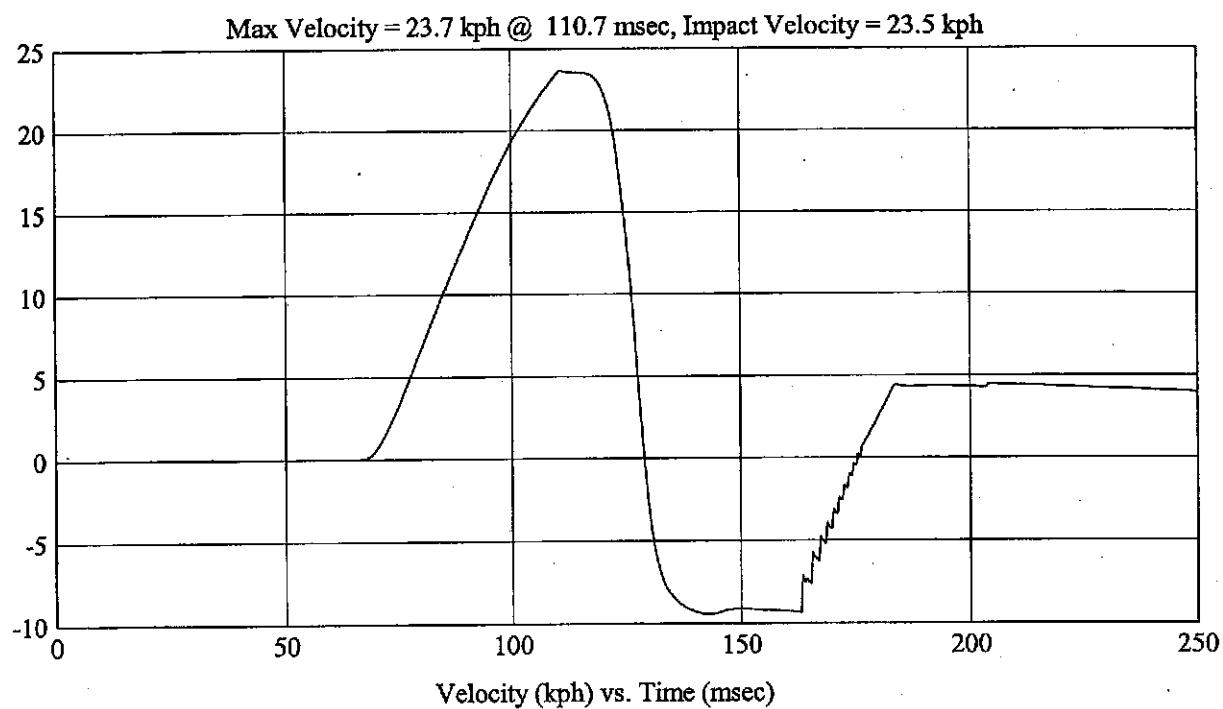
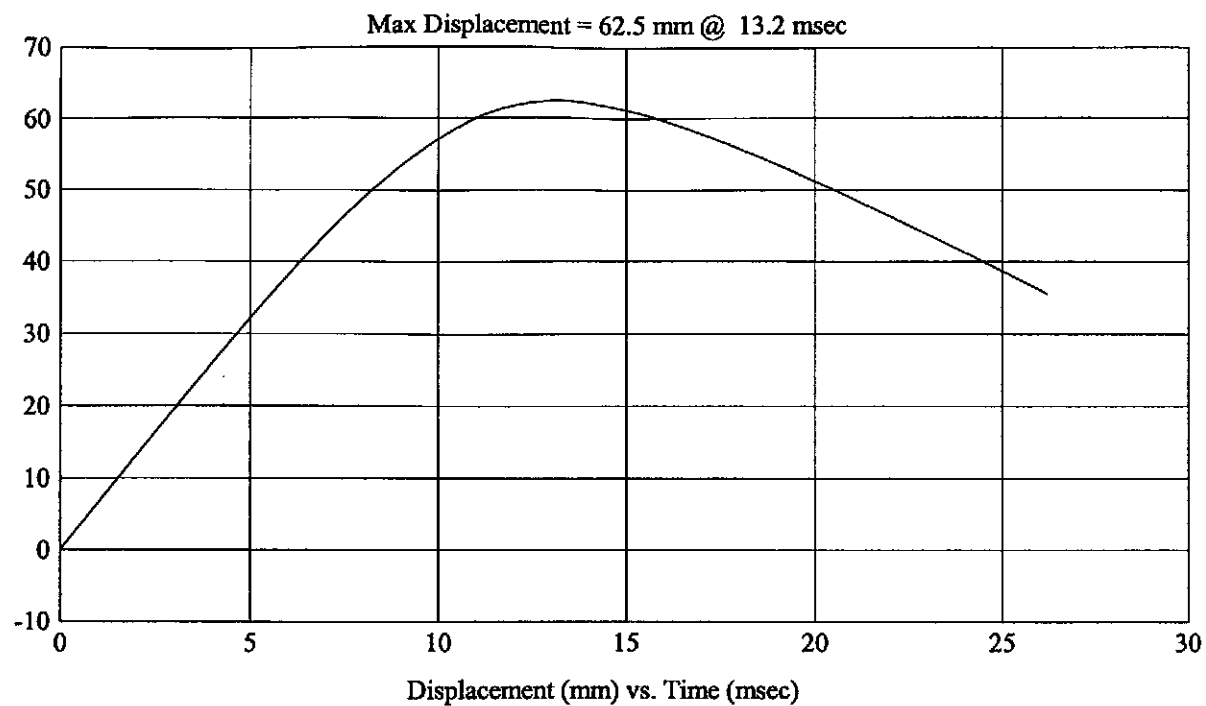
Model Year: 2004
Target: UR5
Vehicle Side: Right
Horz/Vert Angle: 90/36

UR5 Right: The B-Pillar trim was compressed.

HIC(d) = 589, HIC = 560, Delta T = 8.1 msec

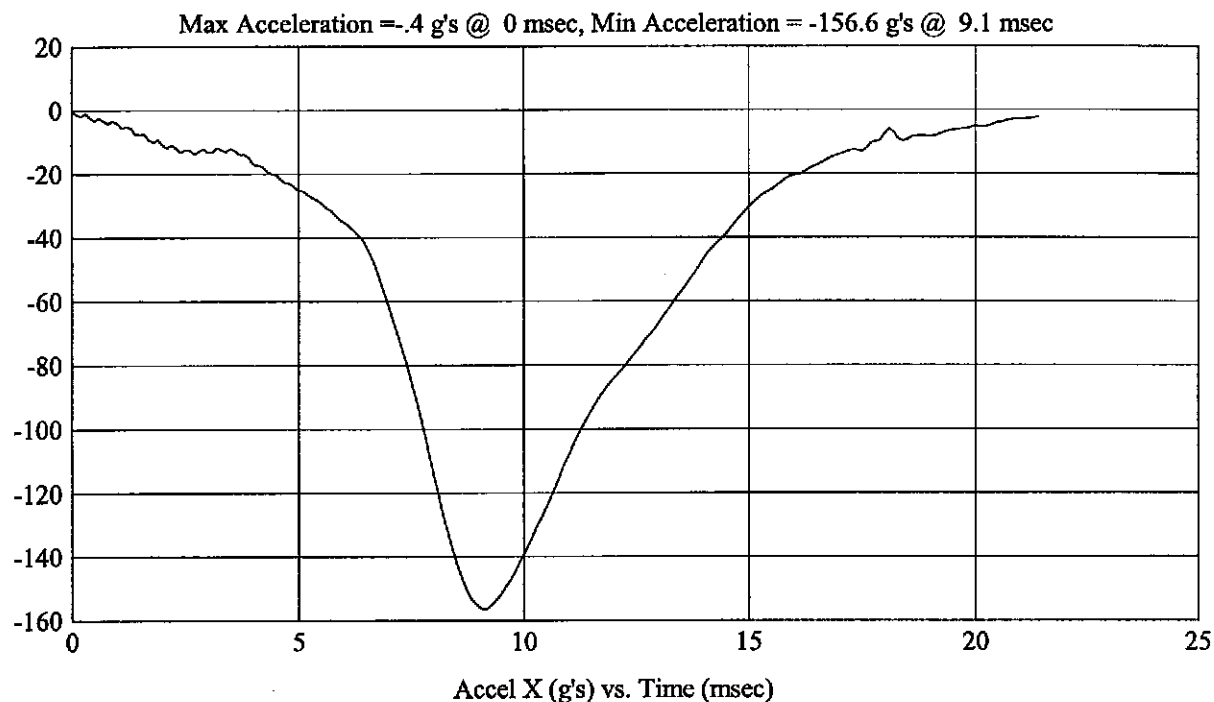
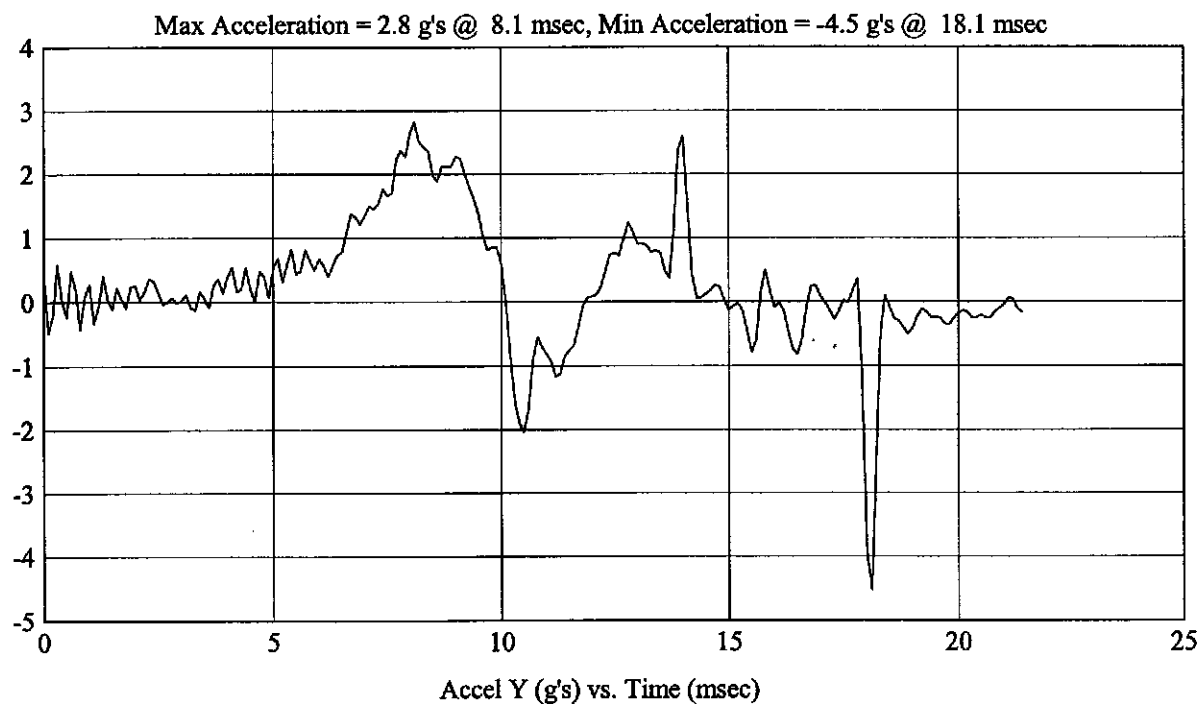
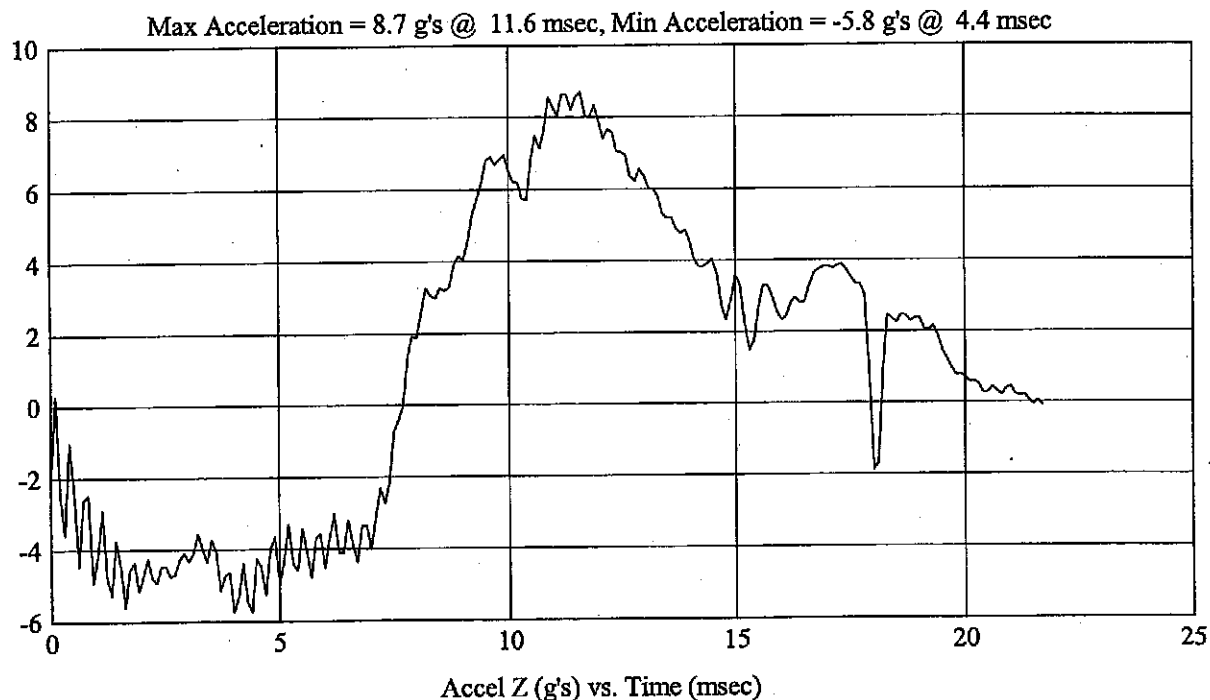
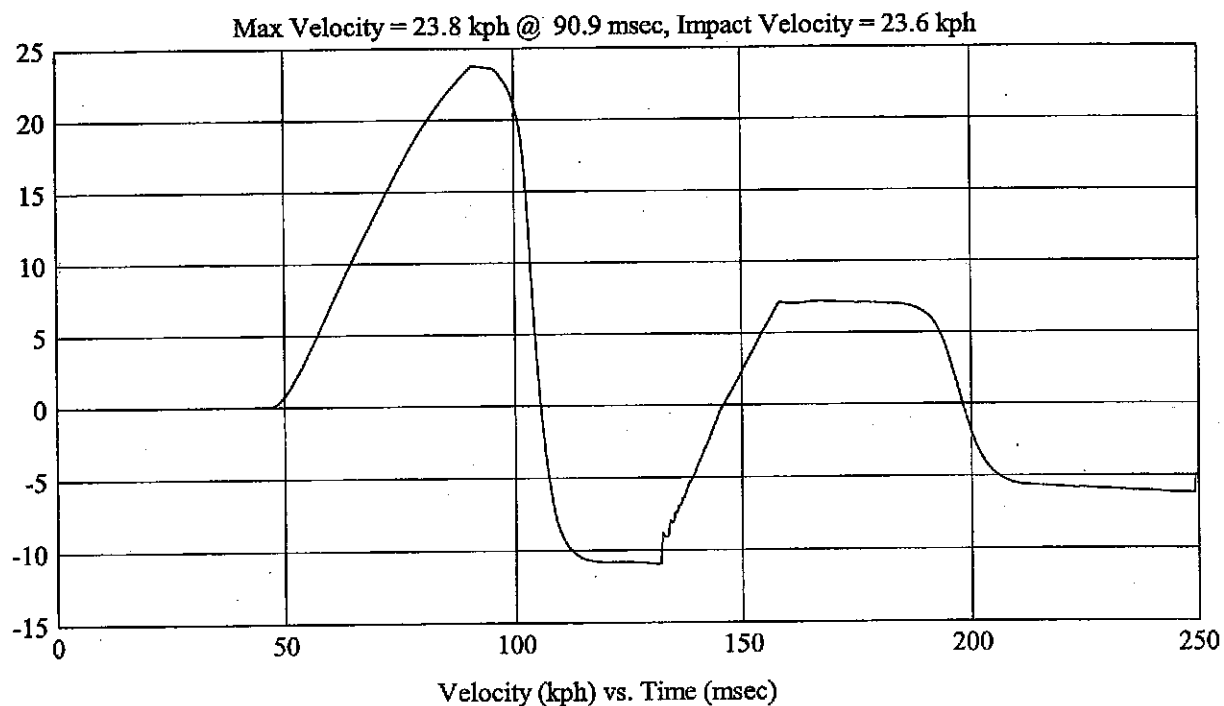
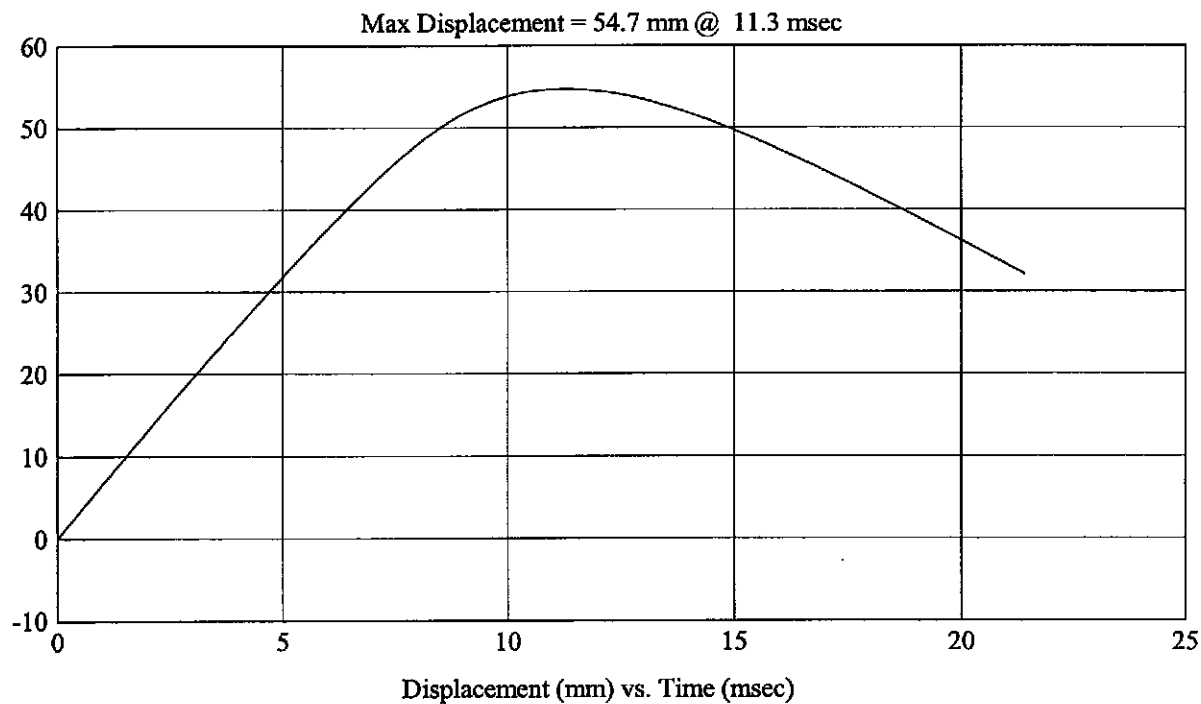
Model Year: 2004
Target: UR6
Vehicle Side: Right
Horz/Vert Angle: 90/38

HIC(d) = 769, HIC = 799, Delta T = 5.9 msec
